U.S. Environmental Protection Agency Vasquez Boulevard I/70 Superfund Site Replacement Certificate

Property Owner	Sharon Bridgeforth , Merriel Scroggins, Johnnie Peters
Property Address	3401 Race Street
Property Identification Number	784

Property Access Checklist

3401 Race St.		Structure:	House								
8/10/2005		Direction:	East								
CM & WH											
9;15 a.m.											
Drawing Number	Photo Number	Painted Surface	Material	Color	Total Area of Element (units ft^2)	Percent Deteriorated	Deteriorated Area (units ft^2)	XRF#	XRF Value	Dos/neg	Notes
Didwing Manibol	- Italipei	T diffica outlase	Material	00.01	(dilles it 2)	Beterioratea	1. 2,	7	7.1.1. 14.45	Foomeg	(100)
		Front Porch Steps	Concrete	Red	n/a	n/a	n/a	154	0.03±0.14	Neg.	
1	1	Front Porch Beam	Wood	White	84.67	50%	42.33	155	11 + - 3.0	Pos.	
		Front Porch									
2	2	Window Frames	Wood	White	1.06	10%	0.11	156	10 +- 2.9	Pos.	
3	3	Front Porch Soffit	Wood	White	63.50	100%	63.50	See 155	11 + - 3.0	Pos.	
		Front Porch									
4	4	Rafters Tails	Wood	White	56.00	100%	56.00		11 + - 3.0		'
5	5	Domer Soffit/Trim	Wood	White	119.10	100%	119.10	See 155	11 + - 3.0	Pos.	
		Front Porch					_				
19		Ceiling	Wood	White	218.92	20%	43.78	1

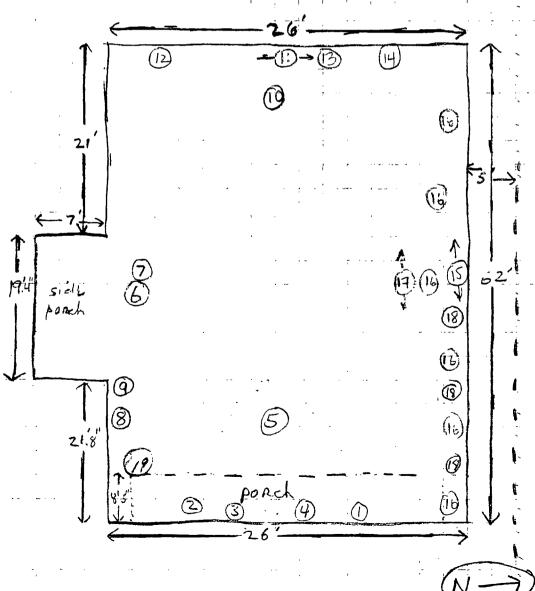
340/ Race

3401 Race St.	1		House			<u> </u>			L	 	
8/10/2005		Direction:	South								
CM & WH							;			i	<u> </u>
9;15 a.m.							i		ļ <u>.</u>		
							<u> </u>		<u> </u>		
	Photo				Total Area of Element	Percent	Deteriorated Area (units			} ;	i

Drawing Number	Number	Painted Surface	Material	Color	(units ft^2)	Deteriorated	ft^2)	XRF#	XRF Value	pos/neg	Notes
6	6	Gable Trim & Soffit	Wood	White	167.87	50%	83.93	See 157	27±4.4	Pos.	
		Upper Window		T				<u> </u>			
7	6	Trim		White _		n/a	2.67			Pos	
			Wood	White	n/a	n/a	28.66	158	0.00+-0.07	neg	
		Basement window									
8	7		Wood	White	n/a	n/a	0.50	See 156	10±2.9	Pos.	
		Main window									
9	7	frames	wood	White	n/a	n/a	4.00	See 156	10±2.9	Pos.	1

Structure:	House								
3401 Race St.		Direction:	West								
8/10/2005											
CM & WH											
	Dhata				Total Area of	1	Deteriorated				
0.45	Photo				Element	Percent	Area (units	V5= "	VDE 14.1	1.	January
9;15 a.m.	Number	Painted Surface	Material	Color	(units ft^2)	Deteriorated	ft^2)	XRF#	XRF Value	pos/neg	Notes
		Dormer soffit &							1	_	I į
10	9	trim	Wood	White	60.84	100%	60.84	See 155	11 +- 3.0	Pos.

l)	Lower soffit &			J	1	J		1	_	
11	10	rafter tails (22)	Wood	White	111.67	100%	111.67		11 + - 3.0		1
12	11	Window frame	Wood	White			1.77	See 159		Pos.	<u> </u>
13	12	Door Frame	Wood	White			3.33	See 159	10 +- 2.7	Pos.	
		Basement window								i	
14	13	cover	Wood	White	7.32	50%	3.66	160	2.1 + - 0.8	Pos.	1
3401 Race St.		Structure:	House	}	1		1	1	i	1	
8/10/2005			North	 	- 		 	1	1	+	
CM & WH				1		[1	
9;15 a.m.	<u> </u>			1			<u> </u>	<u> </u>	† · · · · · · · · · · · · · · · · · · ·	· · -	
	Photo				Total Area of Element	Percent	Deteriorated Area (units			!

Drawing Number	Number	Painted Surface	Material	Color	I	Deteriorated	ft^2)	XRF#	XRF Value	pos/neg	Notes
15	14	Gable trim & soffit	Wood	White	360.00	100%	360.00	See 157	27 + - 4.4		
		Soffit support					<u> </u>		1	+	
16	15		Wood	White	10.67	100%	10.67	¹ 157	27 + - 4.4	Pos.	1
		Basement window		1	-		1	1	,		
17	16		Wood	White	1	i	0.92	161	41 + - 13	Pos.	
		Main level window			1	-	+	1	1		
18	17		Wood	White	1	1	2.33	0 404	41 + - 13	·
